Home Report

Single Survey

Property address	25 North Street Strichen Fraserburgh AB43 6SX
-------------------------	--

Prepared by	Shepherd Chartered Surveyors
--------------------	------------------------------

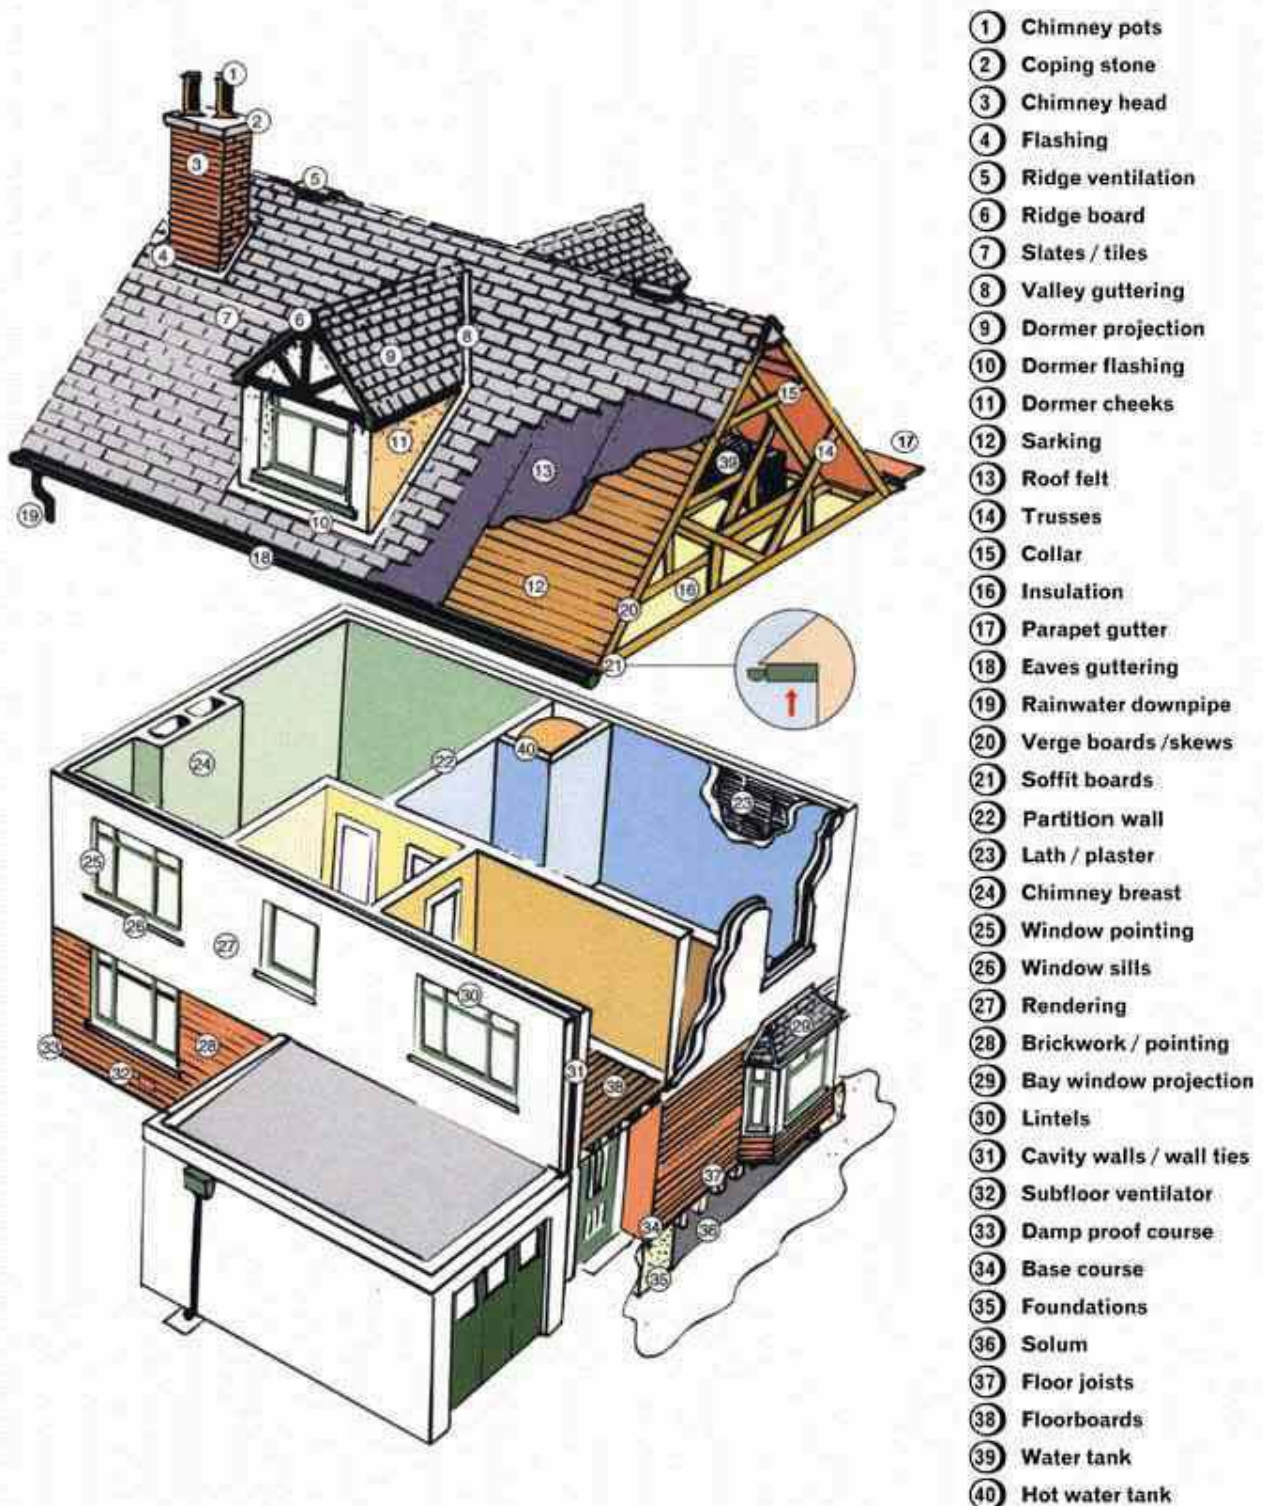
Sectional Diagram showing elements of a typical house

Reference may be made in this report to some or all of the above component parts of the property. This diagram may assist you in locating and understanding these items.
