HOME REPORT

4 GLEBEFIELD TERRACE
CLERKHILL
PETERHEAD
AB42 2BR

Energy Performance Certificate (EPC)

4 GLEBEFIELD TERRACE, CLERKHILL, PETERHEAD, AB42 2BR

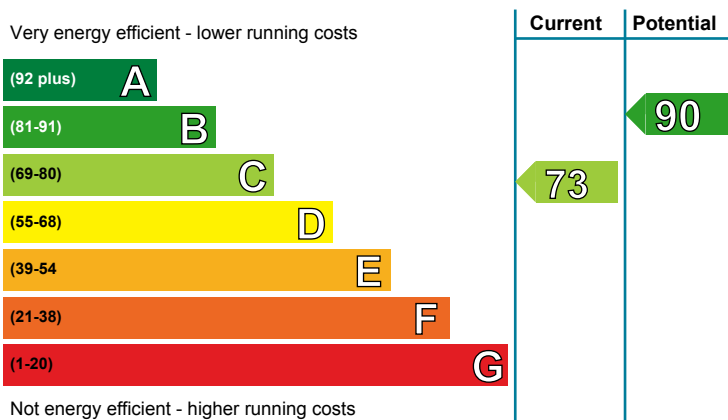
Energy Efficiency Rating

This graph shows the current efficiency of your home, taking into account both energy efficiency and fuel costs. The higher this rating, the lower your fuel bills are likely to be.

Your current rating is **band C (73)**. The average rating for EPCs in Scotland is **band D (61)**.

The potential rating shows the effect of undertaking all of the improvement measures listed within your recommendations report.
