HOME REPORT

THE ELMS
10 STATION TERRACE
LONGSIDE
PETERHEAD
AB42 4UE

ENERGY PERFORMANCE CERTIFICATE

SINGLE SURVEY

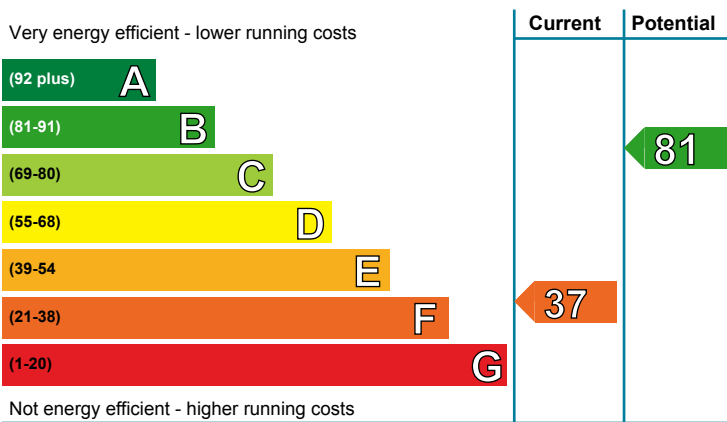
Energy Efficiency Rating

This graph shows the current efficiency of your home, taking into account both energy efficiency and fuel costs. The higher this rating, the lower your fuel bills are likely to be.

Your current rating is **band F (37)**. The average rating for EPCs in Scotland is **band D (61)**.

The potential rating shows the effect of undertaking all of the improvement measures listed within your recommendations report.
