# Home Report

# Scottish Single Survey

| <b>Property address</b> | 7 Low Street<br>New Pitsligo<br>Fraserburgh<br>AB43 6NQ |

| <b>Prepared by</b> | Shepherd Chartered Surveyors |

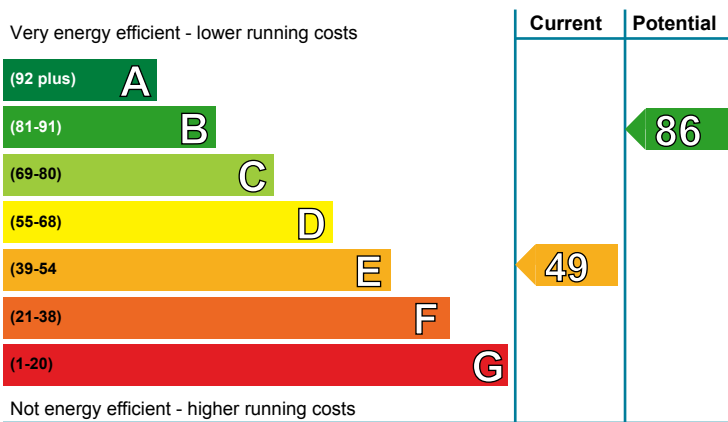
## Energy Efficiency Rating

This graph shows the current efficiency of your home, taking into account both energy efficiency and fuel costs. The higher this rating, the lower your fuel bills are likely to be.

Your current rating is **band E (49)**. The average rating for EPCs in Scotland is **band D (61)**.

The potential rating shows the effect of undertaking all of the improvement measures listed within your recommendations report.
