# Home Report

# Scottish Single Survey

| <b>Property address</b> | 12 Millburn Avenue<br>St. Combs<br>Fraserburgh<br>AB43 8YZ |

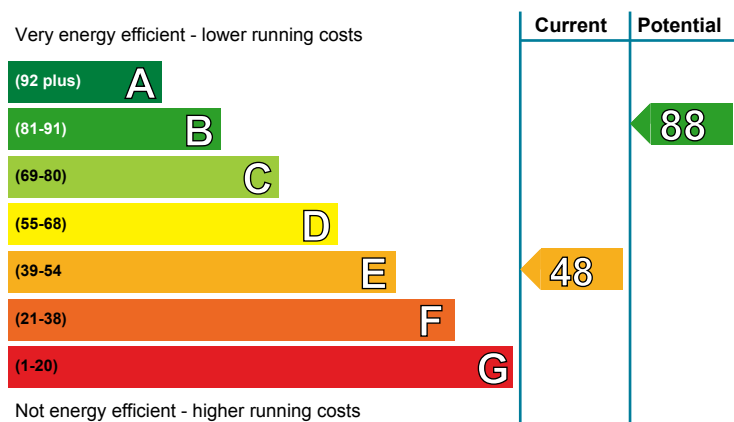
## Energy Efficiency Rating

This graph shows the current efficiency of your home, taking into account both energy efficiency and fuel costs. The higher this rating, the lower your fuel bills are likely to be.

Your current rating is **band E (48)**. The average rating for EPCs in Scotland is **band D (61)**.

The potential rating shows the effect of undertaking all of the improvement measures listed within your recommendations report.

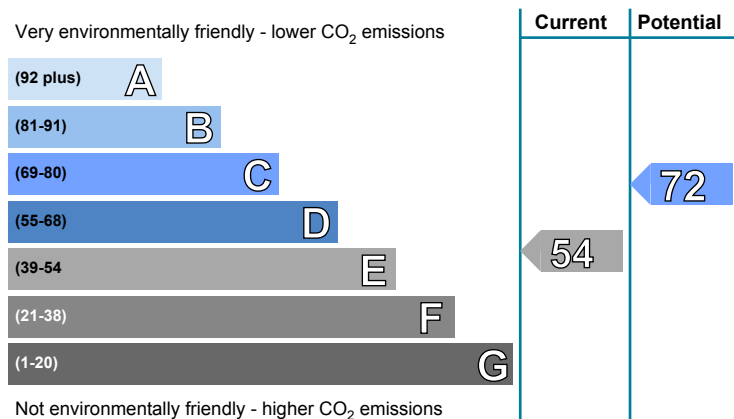
## Environmental Impact (CO<sub>2</sub>) Rating

This graph shows the effect of your home on the environment in terms of carbon dioxide (CO<sub>2</sub>) emissions. The higher the rating, the less impact it has on the environment.
